Medical Devices: The Therac-25*

Nancy Leveson
University of Washington

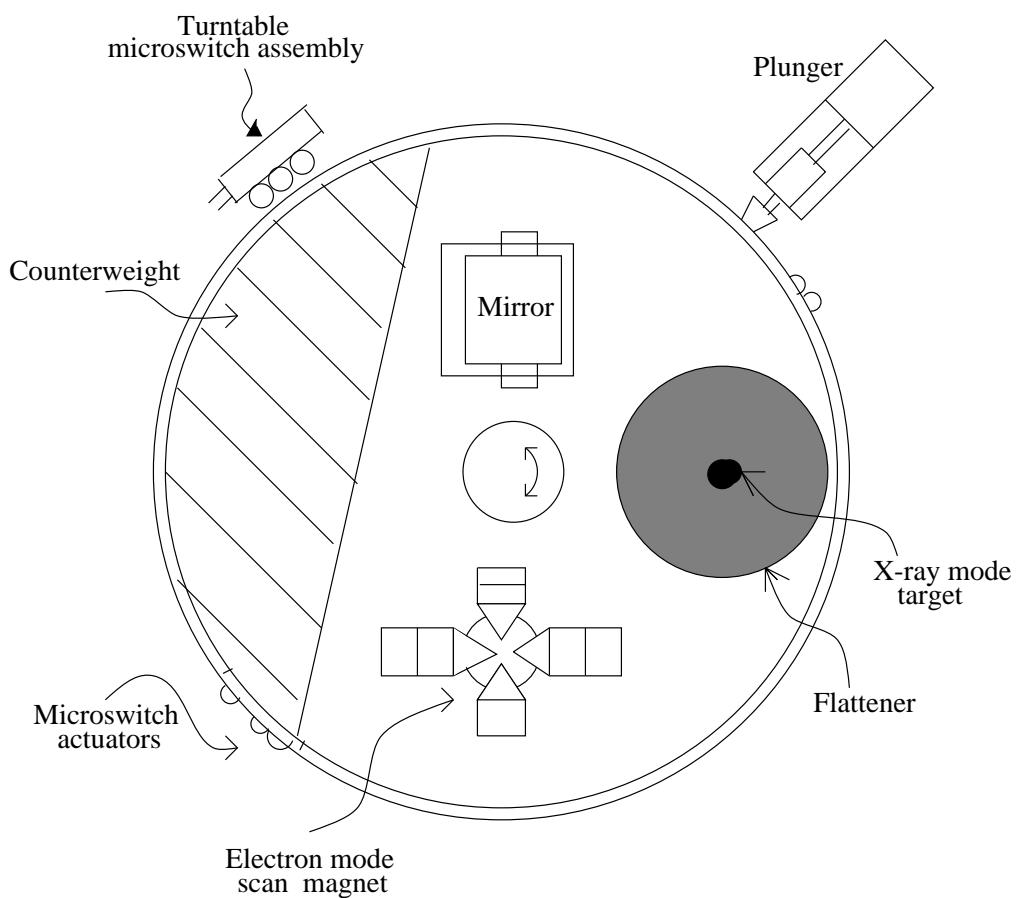
Figure 1: Upper turntable assembly.

Turntable Positioning. The Therac-25 turntable design plays an important role in the accidents. The upper turntable (see Figure 1) rotates accessory equipment into the beam path to produce two therapeutic modes: electron mode and photon mode. A third position (called the field light position) involves no beam at all, but rather is used to facilitate correct positioning of the patient. Because the accessories appropriate to each mode

are physically attached to the turntable, proper operation of the Therac-25 is heavily dependent on the turntable position, which is monitored by three microswitches.

The computer senses and controls turntable position by reading a 3-bit signal about the status of three microswitches in the turntable switch assembly. Essentially, AECL determined that a 1-bit error in the microswitch codes (which could be caused by a single open-circuit fault on the switch lines) could produce an ambiguous position message to the computer. The problem was exacerbated by the design of the mechanism that extends a plunger to lock the turntable when it is in one of the three cardinal positions: The plunger could be extended when the turntable was way out of position, thus giving a second false position indication. AECL devised a method to indicate turntable position that tolerated a 1-bit error so that the code would still unambiguously reveal correct position with any one microswitch failure.

The modifications specified in the Symonds report included redesigning the microswitch and changing the way the computer handled malfunction conditions. In particular, treatment was to be terminated in the event of a dose-rate malfunction, giving a treatment "suspend." This change would have removed the option to proceed simply by pressing the \textcircled{P} key. The report also made recommendations regarding collimator test procedures and message and command formats. A November 8, 1985 letter, signed by the director of the Canadian RPB, asked that AECL make changes to the Therac-25 based on the Symond's report "to be in compliance with the RED act."

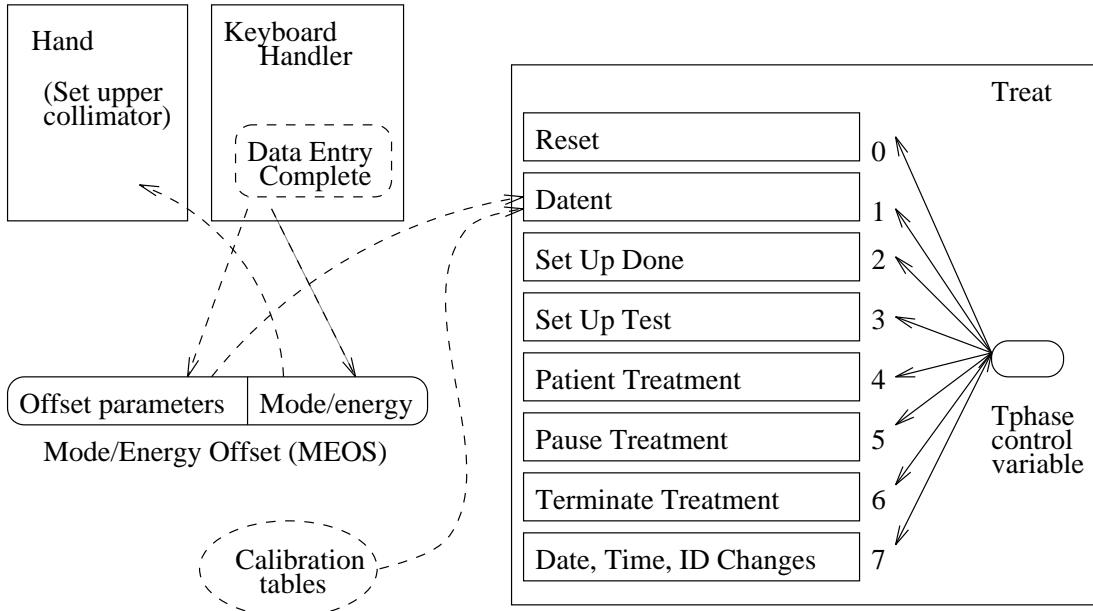
Figure 3: Tasks and subroutines in the code blamed for the Tyler accidents.

The treatment monitor task (Treat) controls the various phases of treatment by executing its eight subroutines. The treatment phase indicator variable (Tphase) is used to determine which subroutine should be executed (Figure 3). Following the execution of a particular subroutine, Treat reschedules itself.

But this is not the only problem. Upon exit from the Magnet subroutine, the data entry subroutine (Datent) checks the Data Entry Complete variable. If it indicates that data entry is complete, Datent sets Tphase to 3 and Datent is not entered again. If it is not set, Datent leaves Tphase unchanged, which means it will eventually be rescheduled. But the Data Entry Complete variable only indicates that the cursor has been down to the command line, not that it is still there. A potential race condition is set up. To fix this, AECL introduced another shared variable controlled by the keyboard handler task that indicates the cursor is not positioned on the command line. If this variable is set, then prescription entry is still in progress and the value of Tphase is left unchanged.

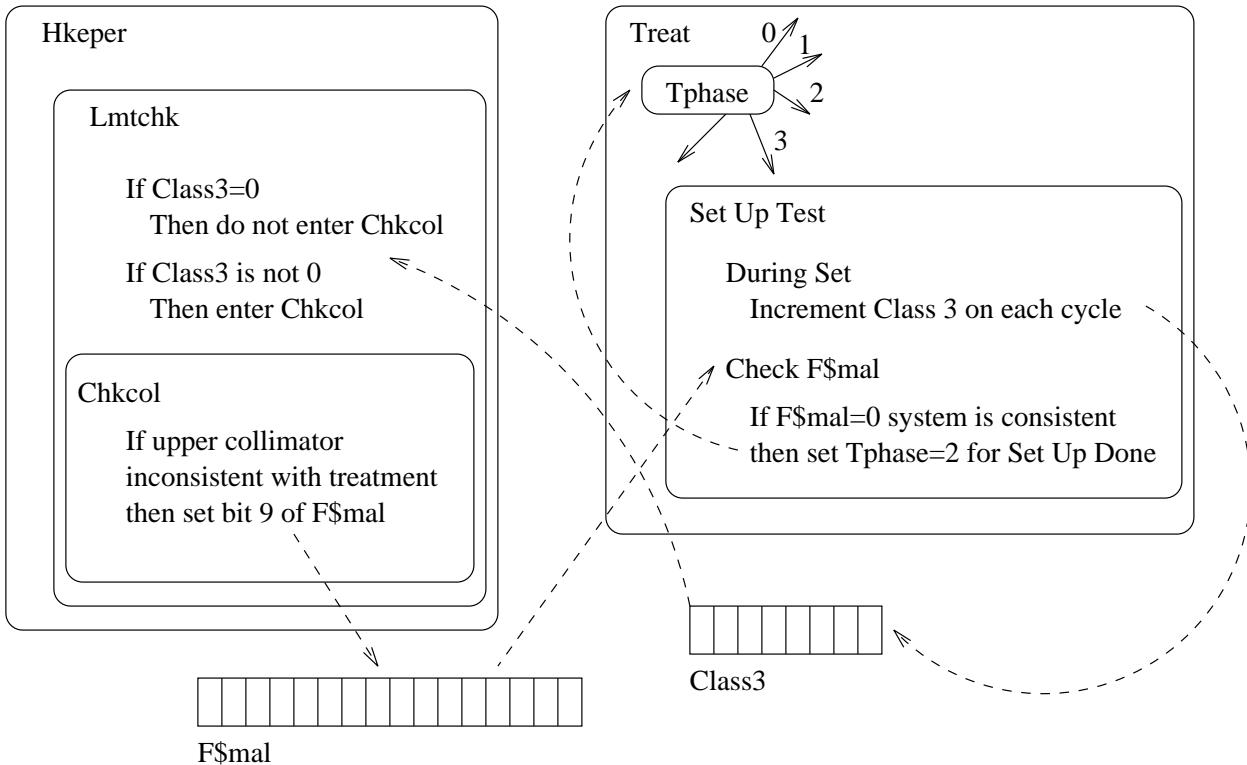
Figure 4: The Yakima software flaw.

The second Yakima accident was again attributed to a type of race condition in the software — this one allowed the device to be activated in an error setting (a “failure” of a software interlock). The Tyler accidents were related to problems in the data-entry routines that allowed the code to proceed to Set Up Test before the full prescription had been entered and acted upon. The Yakima accident involved problems encountered later in the logic after the treatment monitor Treat reaches Set Up Test.

The overexposure occurred when the operator hit the “set” button at the precise moment that Class3 rolled over to zero. Thus, Chkcol was not executed and F\$mal was not set to indicate that the upper collimator was still in the field-light position. The software turned on the full 25 MeV without the target in place and without scanning. A highly concentrated electron beam resulted, which was scattered and deflected by the stainless

- Beam-on will be prevented if the turntable is in the field light or any intermediate position.
- Cryptic malfunction messages will be replaced with meaningful messages and highlighted dose-rate messages.

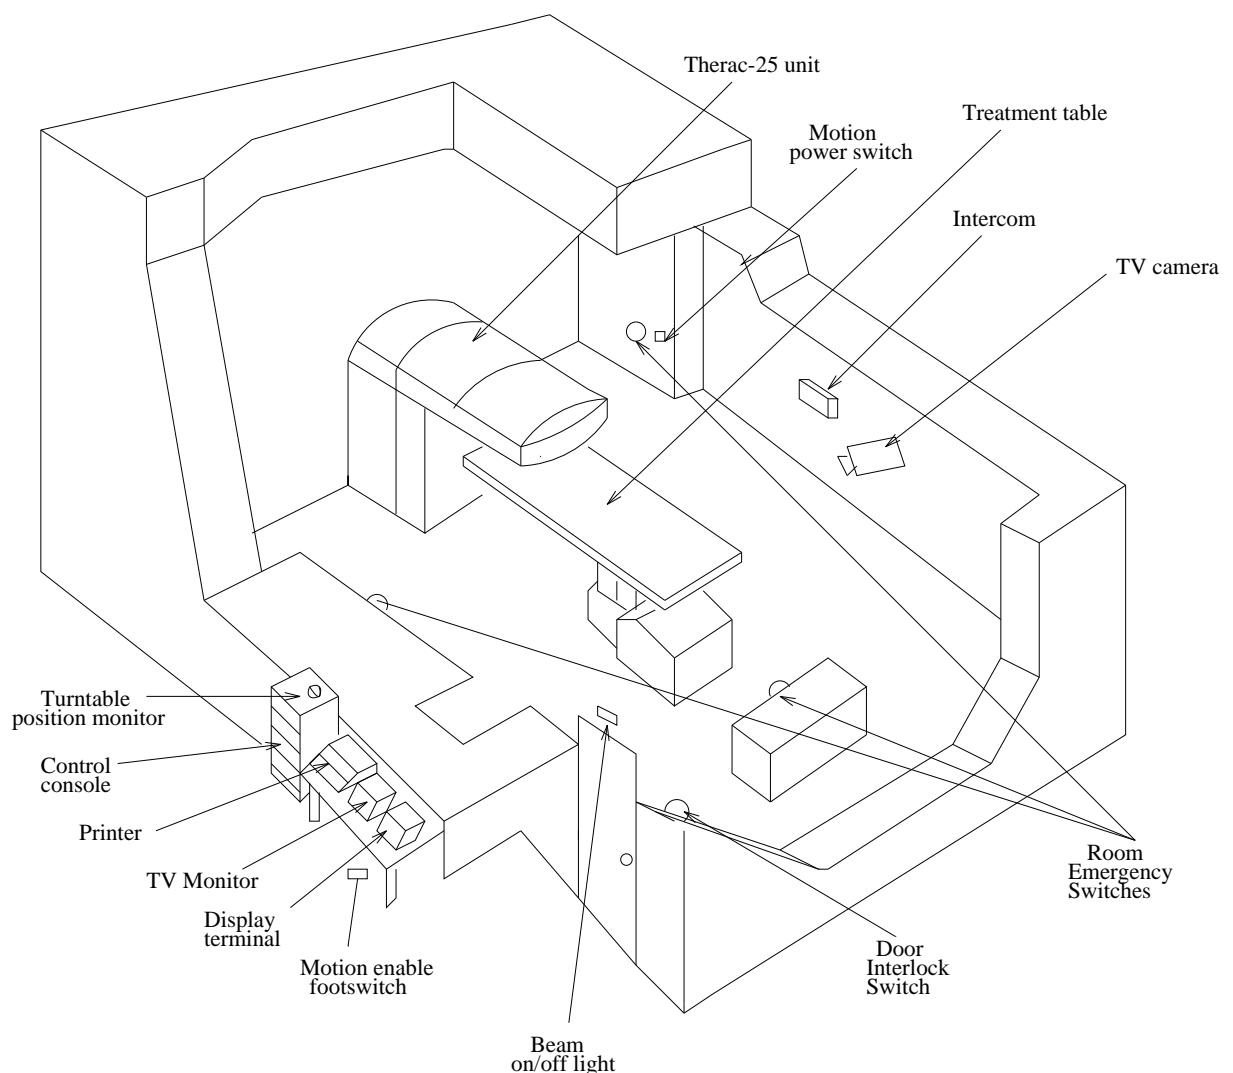
Figure 5: A typical Therac-25 facility after the final CAP.

Figure 5 shows a typical Therac-25 installation after the CAP changes were made.
